**MERIMERE RESERVOIR DAM
CT. 00252**

**PHASE I INSPECTION REPORT
NATIONAL DAM INSPECTION PROGRAM**

SEPTEMBER 1978

Identification Number: CT 00252
Name: Merimere Reservoir Dam
Town: Berlin
County and State: Hartford County, Connecticut
Stream: Stocking Brook
Date of Inspection: July 25, 1978

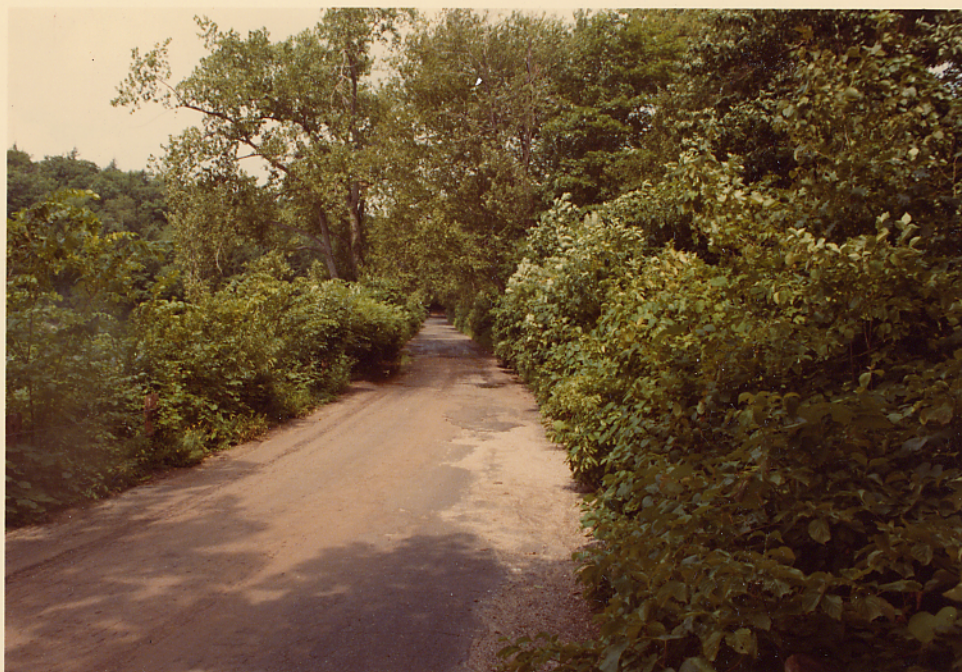
PHOTO 1
ROADWAY ON CREST OF DAM

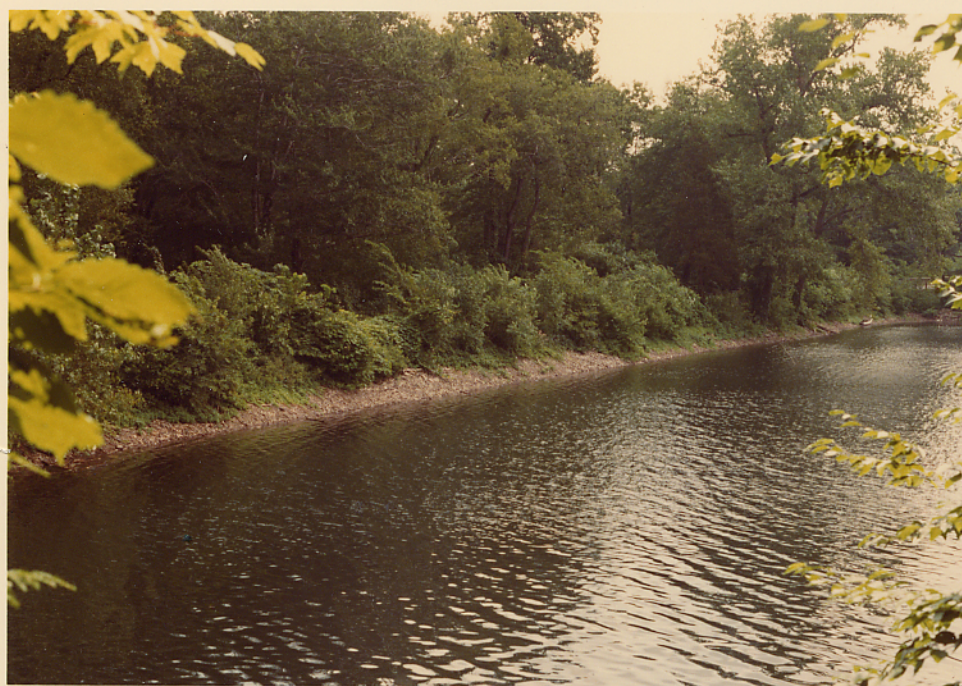
PHOTO 2
UPSTREAM FACE OF DAM

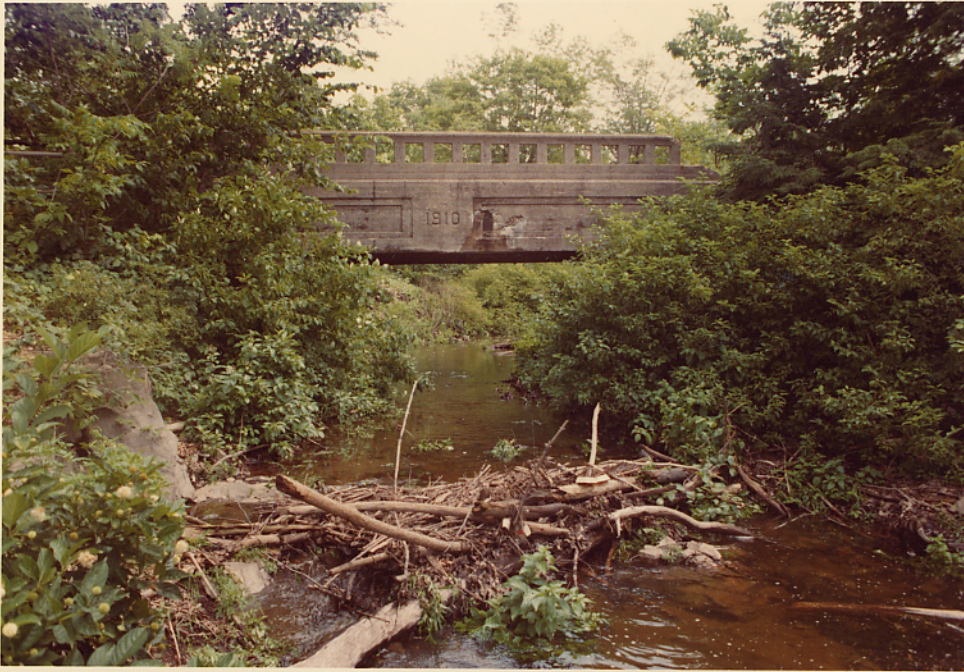
restoration. The service bridge has an opening of approximately 7' x 28' and the concrete beams are in remarkably good condition. There were no evidences of major cracks or spalling noted.

PHOTO 3
SERVICE BRIDGE LOOKING DOWNSTREAM

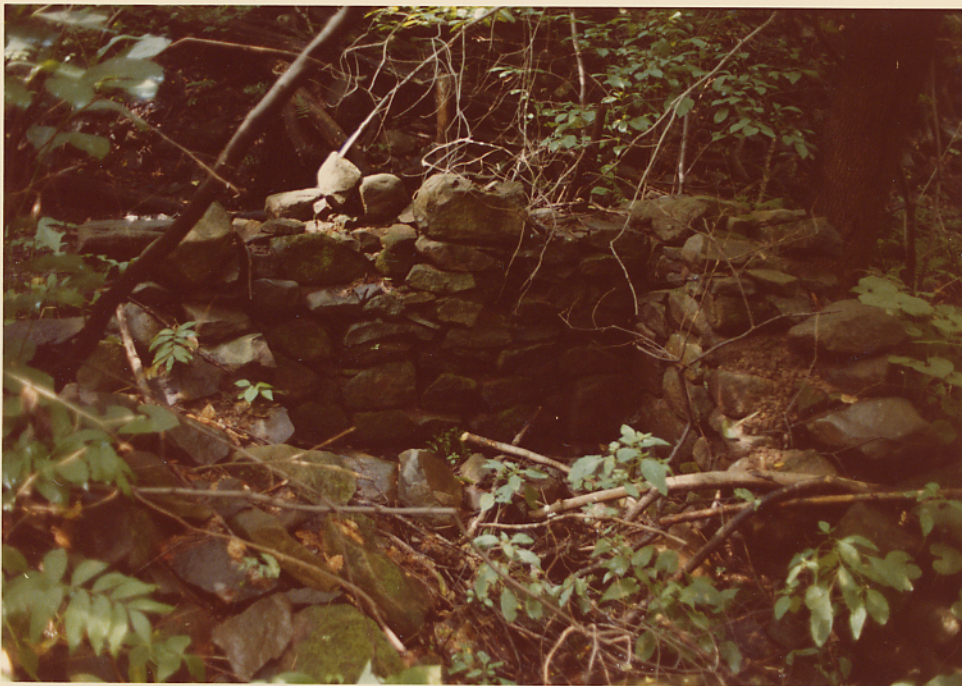
PHOTO 4
HEADWALL AT DOWNSTREAM FACE OF DAM

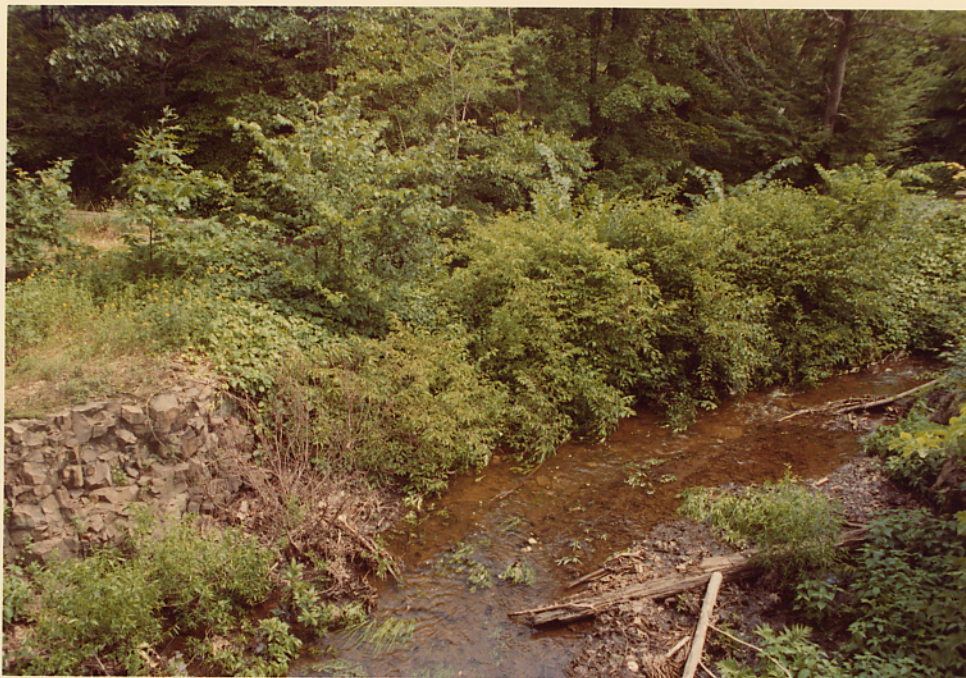
c. Visual Observations - The spillway at the time of inspection was in fair condition. The weir and the spillway channel for approximately 50 feet was heavily overgrown with brush and trees.

PHOTO 5
SPILLWAY FROM UPSTREAM AREA

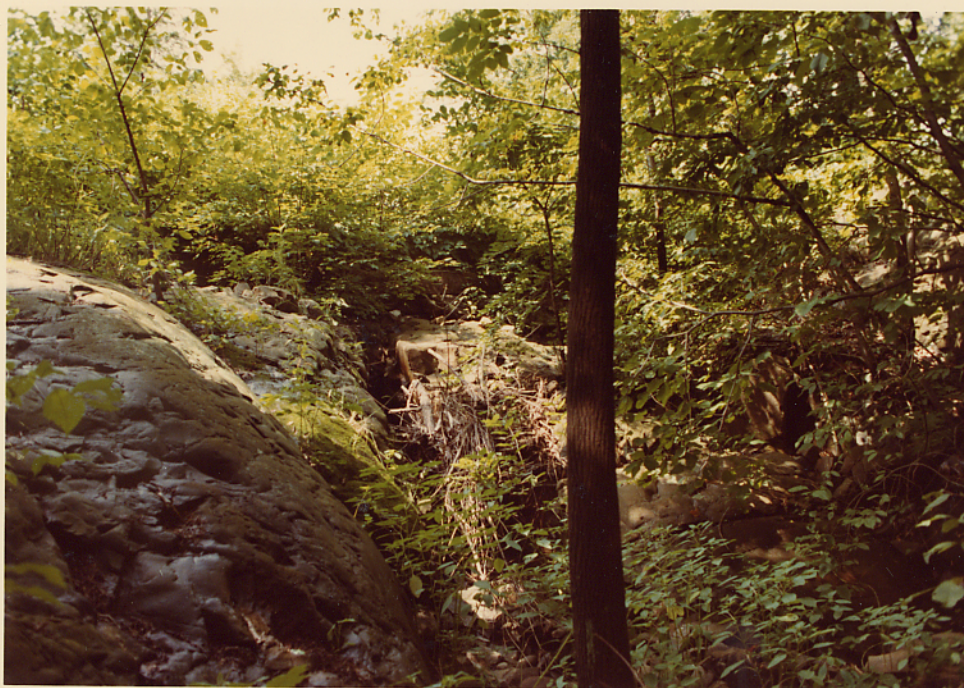
e. Downstream Channel - The downstream channel of the spillway is overgrown with trees and is very difficult to define its actual location. The channel seems to follow the natural fall and presently has no form of slope protection. It stays moist from the seepage flows out of the body of the dam.

PHOTO 6
SPILLWAY FROM DOWNSTREAM AREA

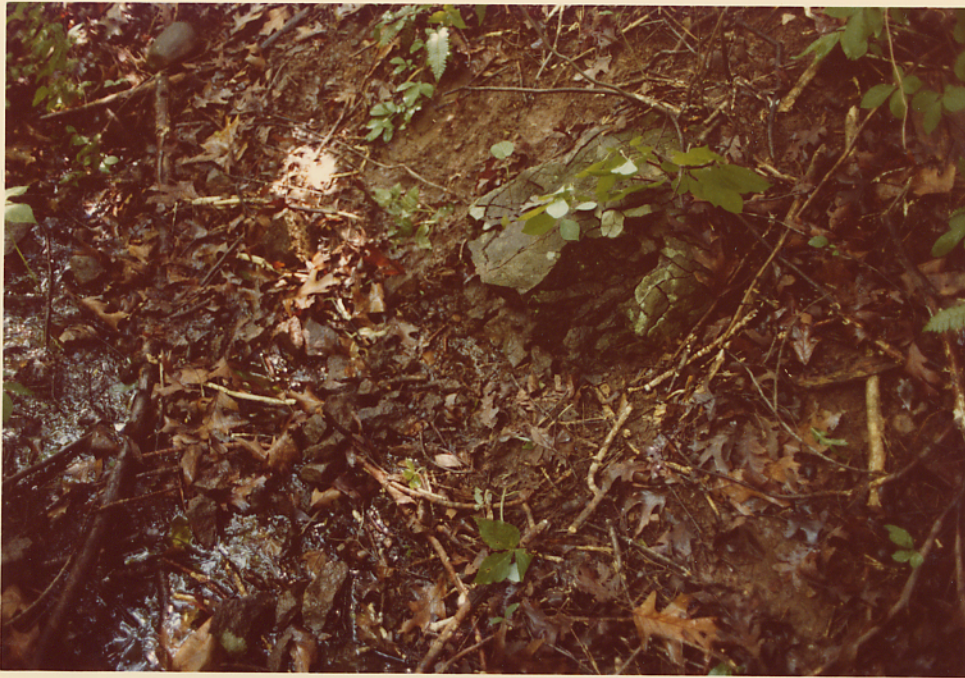
This visual inspection discovered an intensive zone of seepage through the body of the dam which causes concern about its structural stability in the future.

PHOTO 7
SEEPAGE AREA AT TOE OF DAM

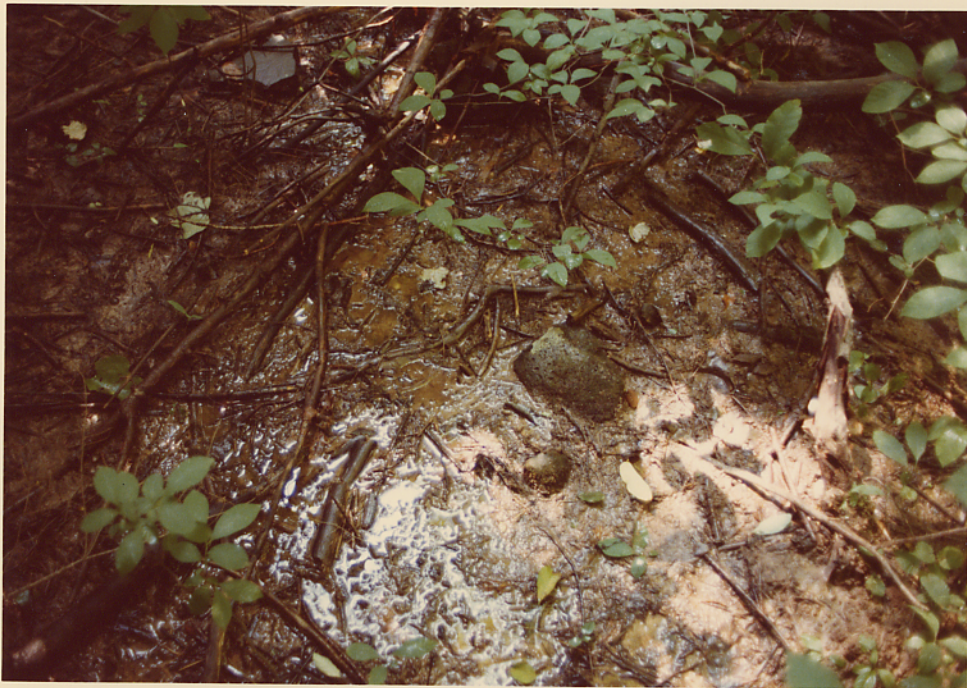
PHOTO 8
SEEPAGE AREA AT TOE OF DAM
